Manhole Inspection Summary

Manhole # S23G1_007MH

Location Address: **2647 Northshire Rd.**

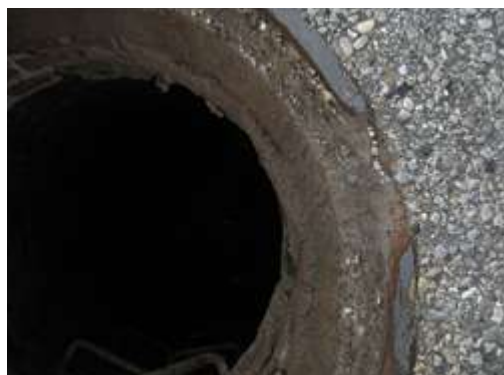
Defect 6

☒ **Cracked**

☒ **Leaks**

Frame Cracked, Frame Infiltration

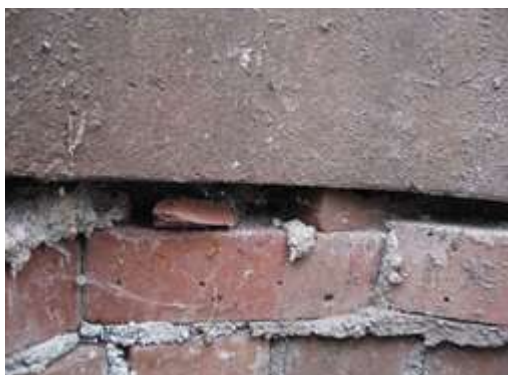
Defect 5

☒ **Cracked**

☒ **Loose Brick**

☒ **Deteriorated**

Chimney Loose Bricks, Cracked and Deteriorating

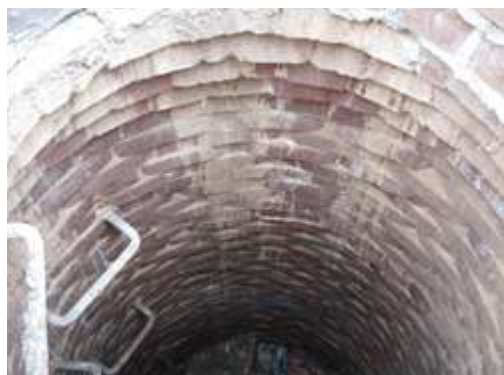
Defect 4

☒ **Joint**

☒ **Cracks**

☒ **Mortar**

Chimney Infiltration

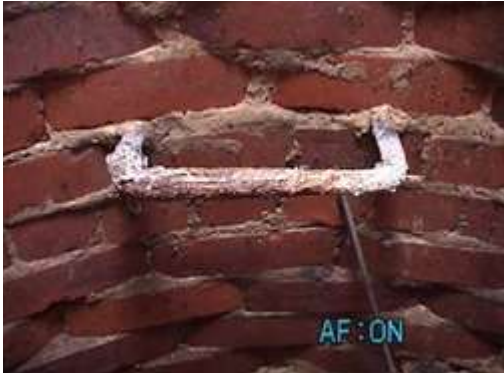
Defect 3

☒ **Corroded**

Corroded stps

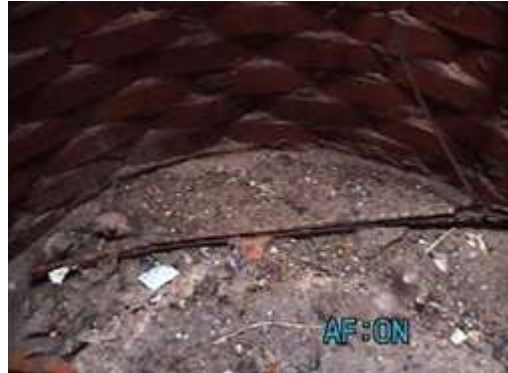
Defect 2

Bench Debris

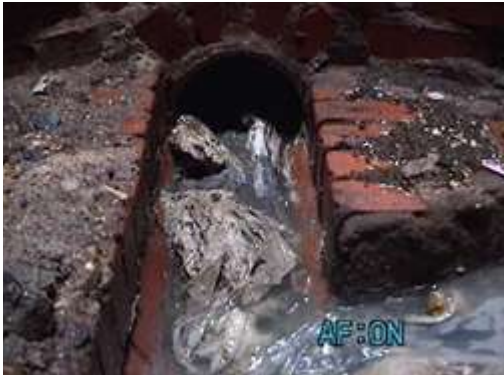
Defect 1

Channel Debris

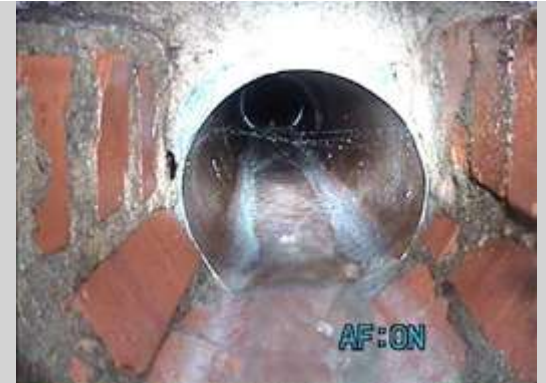
12 O'Clock Outflow

8 in. Circular Gravity Sewer
Pipe Out @ 12 O'Clock

Infiltration: **None** Pipe Seal Cond: **Sound**

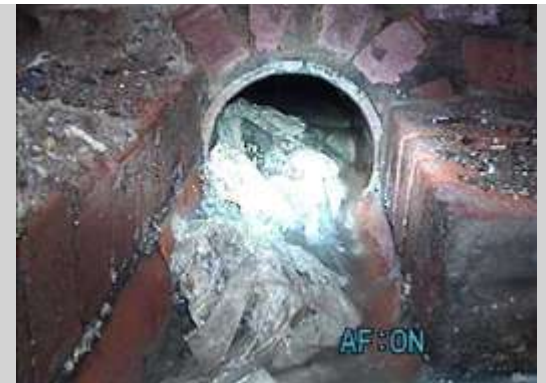
6 O'Clock Inflow

8 in. Circular Gravity Sewer
Pipe In @ 6 O'Clock

Infiltration: **None** Pipe Seal Cond: **Sound**

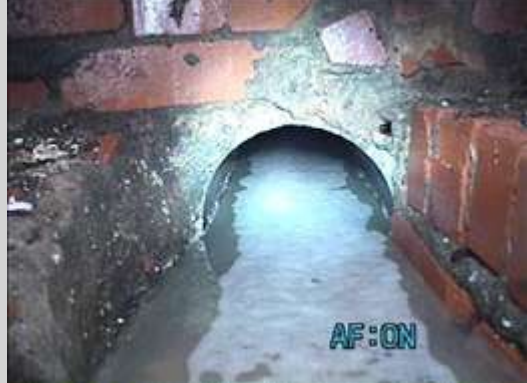
9 O'Clock Inflow

8 in. Circular Gravity Sewer

Pipe In @ 9 O'Clock

Infiltration: **None** Pipe Seal Cond: **Sound**
